FRANCIS E. WALTER DAM

CONDITION REPORT

DAM, OUTLET WORKS & SPILLWAY
PERIODIC INSPECTION REPORT NO. 3

NOVEMBER 1976

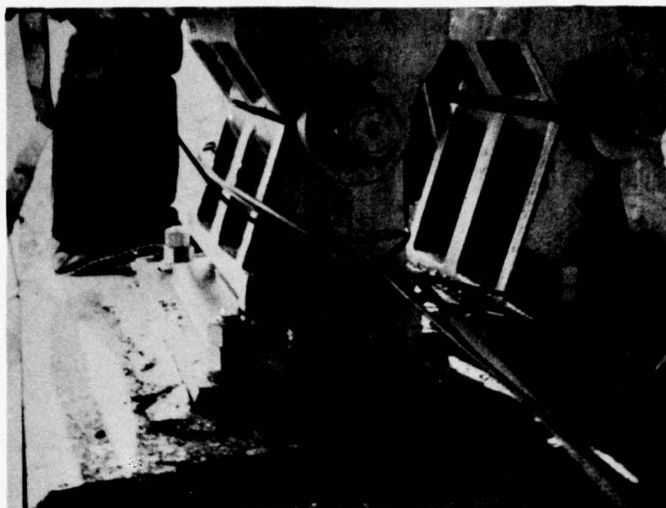
A close-up inspection of the bearings on Pier No. 2 was performed from the pier cap. The rockers of both expansion bearings were found to be in a rotated position and displaced longitudinally in the expansion direction with the teeth on the base plates disengaged from the notches in the rocker rims. See Photos #1 through #4, and #7 through #11, Appendix A. The bearing surfaces of the rockers and base plates were found to be in contact across their full widths but the lines of contact were displaced approximately 3 inches off-center towards the fixed bearings. See Photo #12, Appendix A. Measurements of base plate setting and rocker displacement were obtained and degree of rotation computed for both expansion bearings. See Plates 1 and 2. Some anchor bolts were found to be offset relative to center of slotted hole to the extent that very little, if any, adjustment of base plate location could be made. See Photos #5 and #6, Appendix A.

PIER NO. 2 - EAST SIDE
EXPANSION BEARING (LEFT) SEEN FROM INSIDE GIRDER
PHOTO #1

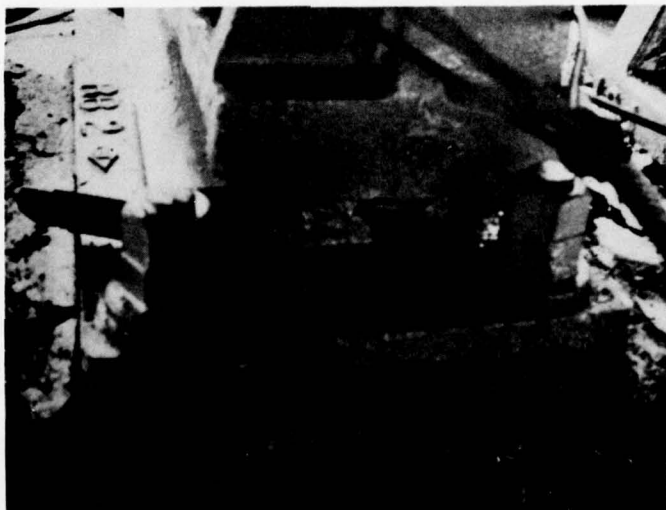
3-02. ABNORMAL CONDITIONS. The disengagement of rocker and base plate in each expansion bearing on Pier No. 2 has caused the rim of the rocker at the notch to rest upon the top of the tooth. Rotation of the rocker to allow contraction of the middle span is thereby prevented. Expansion capability for all spans appears to be unaffected.

PIER NO. 2 - EAST SIDE
CLOSE-UP OF ABOVE SHOWING DISENGAGEMENT OF ROCKER
AND BASE PLATE
PHOTO # 2

a. Corrective Measures. As a result of this investigation, it is concluded that remedial action is not necessary at this time and that the structure may be used to its full design load capacity without harmful stress overloads. However, it is recommended that funds be programmed to correct the condition.

Another method to be considered would also require jacking of the girders, allowing repositioning of the expansion shoes on the girder ends to align vertically with the base plates. This would entail removal of shoe mounting bolts and interfering rivets and welding of the shoes in the new position. Relocation or addition of end stiffeners might also be required. This method would eliminate the slight eccentricity occurring on the pier cap from dead load reactions under the present condition.

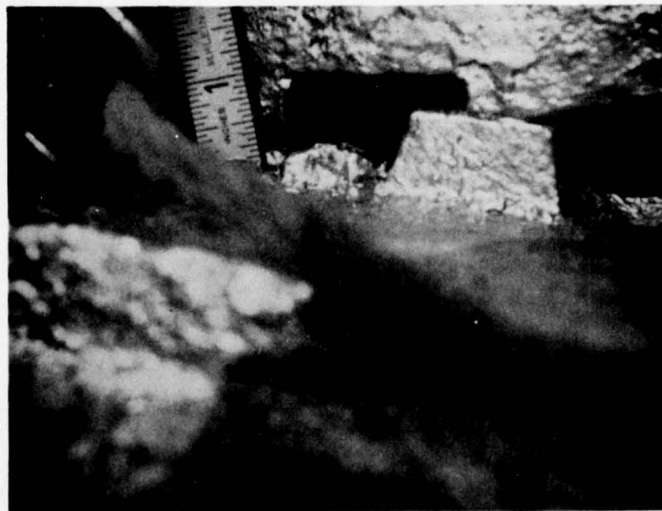
PIER NO. 2-EAST SIDE
CLOSE-UP OF ABOVE SHOWING DISENGAGEMENT
PHOTO # 4
